THE INFLUENCE OF THERMOMECHANICAL PROCESSING
AND HEAT TREATMENT ON THE FATIGUE RESISTANCE
AND FRACTOGRAPHIC CHARACTERISTICS OF
A HIGH-CARBON BEARING STEEL

NAVAL POSTGRADUATE SCHOOL

THESIS

December 1979

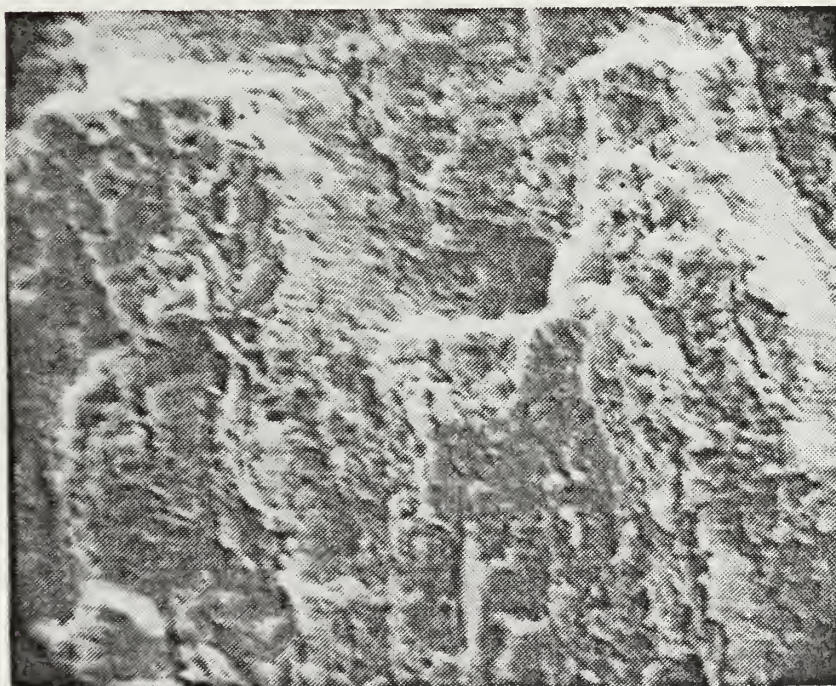
Figure 33. Higher magnification view of the fast fracture region B of Fig. 30, showing characteristic fracture surface of "lamella shape." X1200.

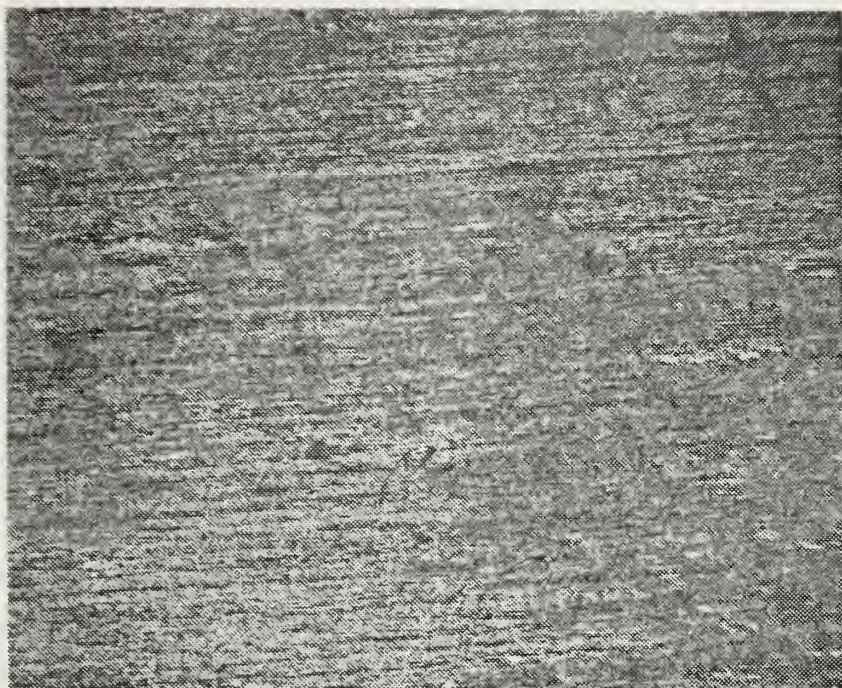
Figure 42. Micrograph of specimen AR-4-10 in Fig. 39, etched with 2% nital + 2% picric acid solution for 10 seconds. The rolling direction is parallel to the plane of the specimen and horizontal in the micrograph. X100.

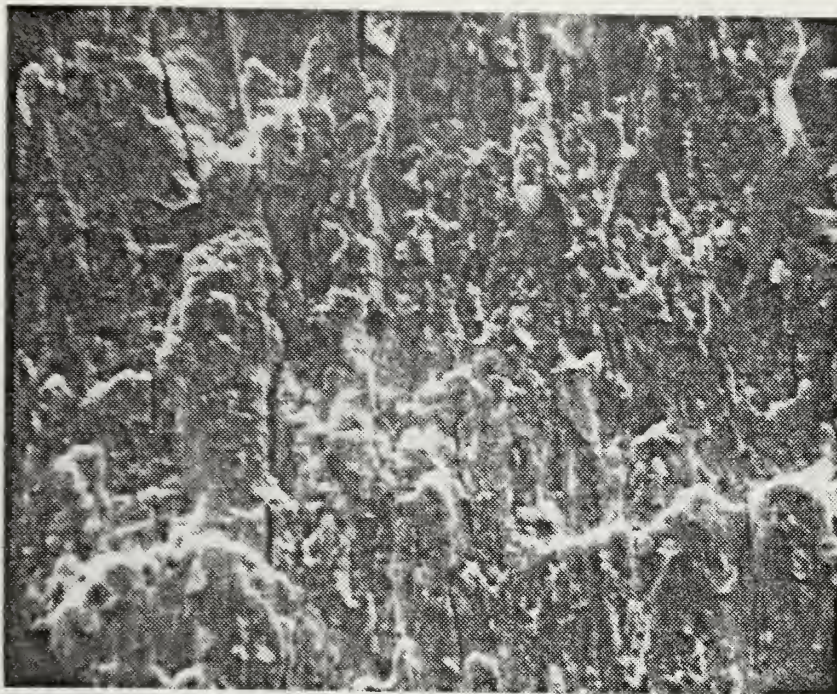
Figure 50. Higher-magnification view of the outlined area in Fig. 49, showing quasicleavage fracture with tear ridges. X1000.
